BLACKSTONE RIVER BASIN
AUBURN, MASSACHUSETTS

STONEVILLE POND DAM
MA 00126

PHASE I INSPECTION REPORT
NATIONAL DAM INSPECTION PROGRAM

AUGUST 1978

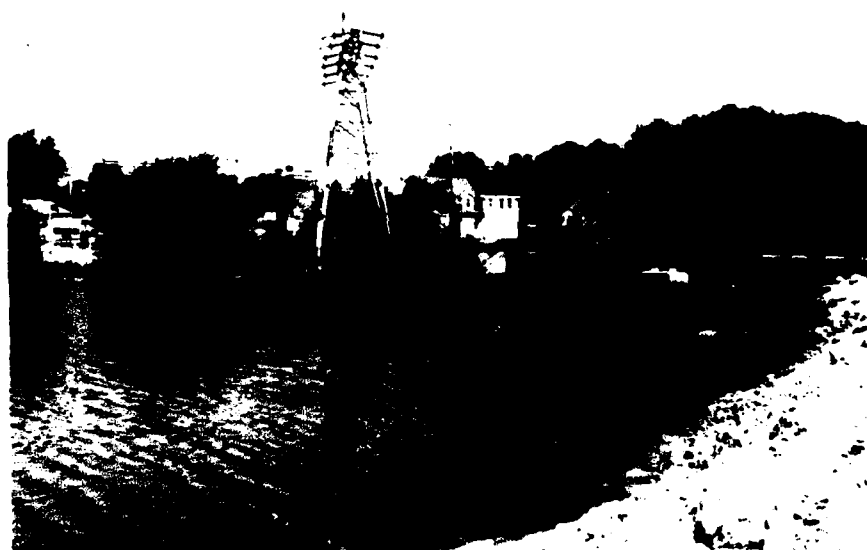
VIEW FROM SOUTH EDGE OF POND

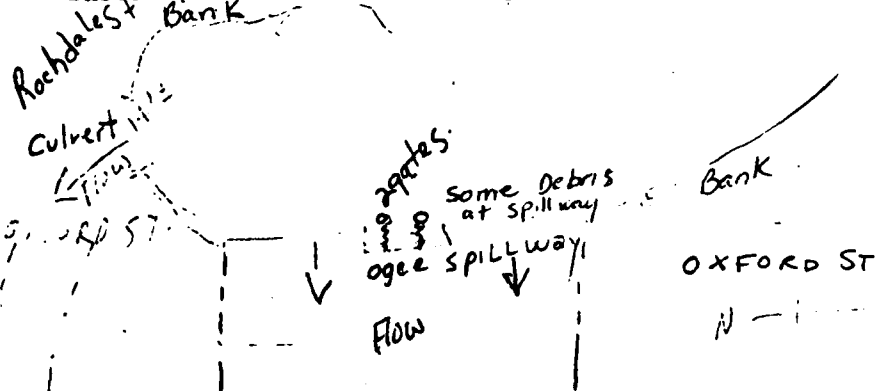
Sketch (Not to Scale): Rockdale ST Bank

Remarks and Recommendations:
 water flowing about 3" over ogees spillway at time
 of inspection some brush growing near abutments
 concrete scaling at gates
 * GATES APPEAR TO BE INOPERABLE
